INTERVENTION SOLUTIONS ON LANDSLIDES IN ROAD AREAS. CASE STUDY

Abstract. In our country, there is a large variety of foundation soils, some of them having inferior characteristics to those necessary for the proper support of a communication path. This raises some of the most common problems in the field of road infrastructures, namely the sliding of slopes in the area related to road construction. This phenomenon appears more and more frequently, especially after some periods with accentuated atmospheric instability, sometimes leading to the partial inability to use the affected infrastructure sector. In some cases, the development of this phenomenon can lead to the traffic blockage and the isolation of the communities in the area, to the destruction of a well-defined road sector and even to the loss of human lives. In order to maintain the quality requirements imposed by the law and to limit the risk of reaching the limit state of normal operation, respectively of compromising the structure, the administrators and the staff who are directly involved in the maintenance and the expertise of the affected area, achieve direct examination works or investigation by means of specific ob

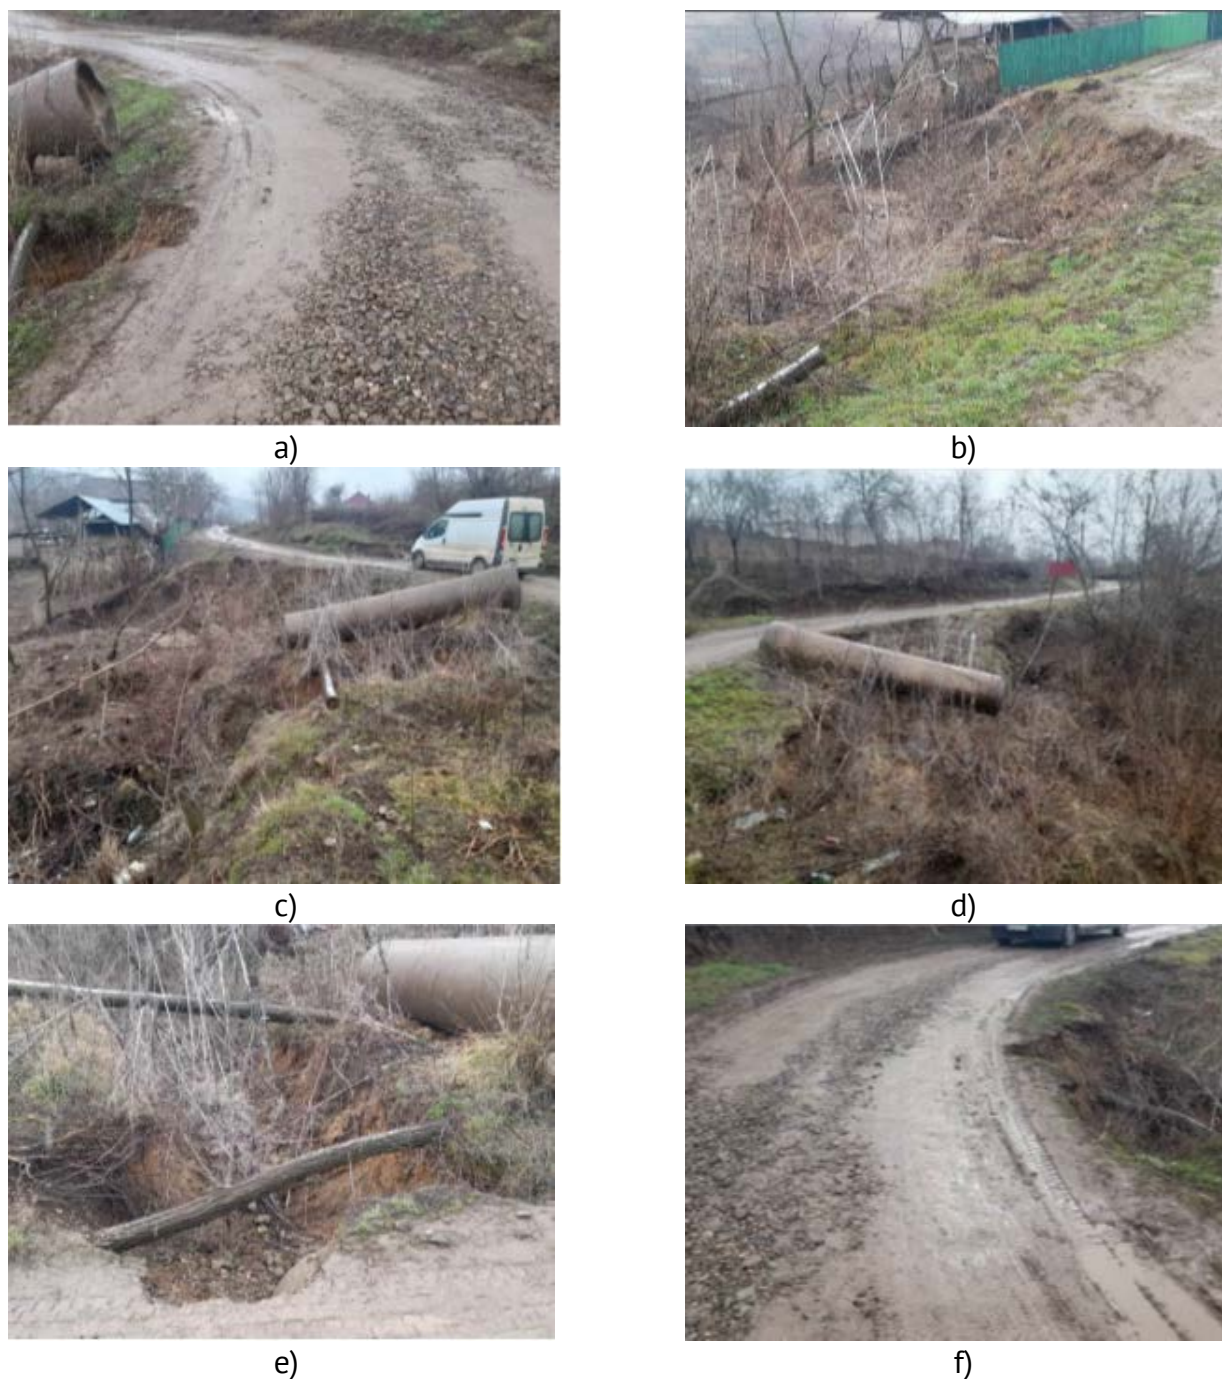
Along the analyzed route, a slope was identified with stability issues (Figure 1), unevenness, and potholes caused by the lack of drainage and maintenance systems, as well as erosion forms on the sloping areas, given that the road embankment was supported by a structure made of gabions. The area belongs to the high-risk area for soil collapse or landslide, with a high probability of primary landslide occurrence.

Intense weather conditions have heavily impacted the road sector, causing a 40 meters length landslide along the road embankment. Successive break steps were observed that threaten the overall stability of the road.

In the partially forested upstream slope, saturation areas were formed due to precipitation which softened to the point of flow. The flowing material and water from the slope are uncontrolledly discharged onto the road. Upstream zones of counter-slope have also been identified, which have favored the flooding of precipitation.

At the base of the excavation slope there is no walled ditch for collecting the waters, and the existing bridge is silted and does not have a drop chamber for collecting upstream and trench water.

Figure 1. The analyzed landslide.

- The main recommendations aim to eliminate all possibilities of water infiltration into the land and its wetting with a negative effect on the construction, respectively:

- The arrangement of a reinforcement structure made of drilled piles with a minimum diameter of 600 mm, at a minimum depth of 14.0 m. The piles will be spatially positioned, at a distance in the plan, calculated so that the earth does not flow between the piles.

- The arrangement of a horizontal drainage system under the bottom of the ditch to collect the water from seepage. The depth of the drain will be at least 2.00 m. It will have a minimum length of 40 m.

- Restoration of the water discharge bridge. It is recommended that the bridge foundation rests on the reinforcement structure in the downstream area.

- Development of the torrential valley on the upstream and downstream area for a minimum of 25-30 m. An initial systematization of the land both downstream and upstream is recommended, then protection with gabion mattresses/geocells filled with concrete.

- Restoring the road body and ensuring the designed width.

- Ensuring adequate storm water collection and drainage systems to avoid their infiltration into the road system, which can have a negative effect on the appearance of subsidence and cracks in the road body. They can be trapezoidal ditches, triangular ditches, rectangular ditches, etc.

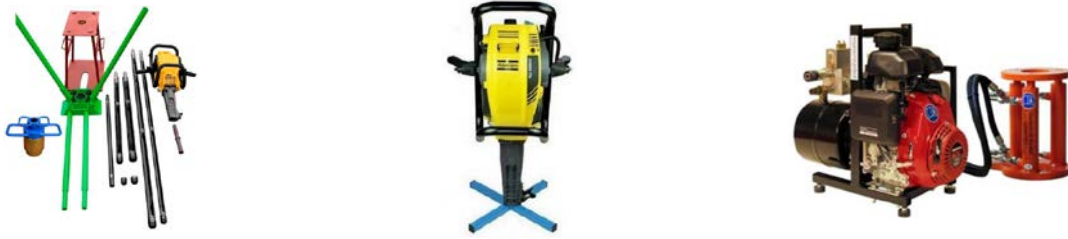
The system used for drilling (Figure 6) consists of:

- percussion hammer with internal combustion engine on gasoline
- hydraulic extractor - pulling power of 10 tons
- drill bits with diameters between 36 - 100 mm and lengths between 1.0 and 2.0 m
- connecting rods with lengths between 1.0 and 2.0 m
- utility vehicle used for mobilization on site, equipment transport, and maintenance on site
- wooden boxes for transporting samples to the laboratory
- stands and pipes for collecting undisturbed samples
- electric generator and concrete/asphalt corer - to cross any concrete/asphalt platforms.

Figure 6. Heavy Dynamic Cone Penetrometer Equipment [15-17].
